# Scope of works

## West Quay

**LOCATION: Southampton**  
**CLIENT: ABM Technical Solutions**

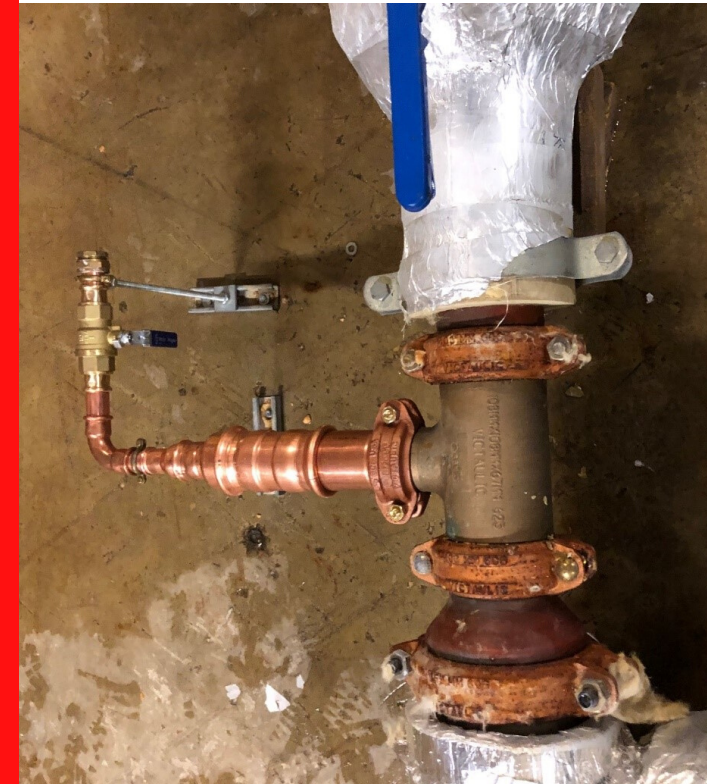
Beatties were contacted to rectify a major water leak on the main Cat 5 water pipework, to prevent the Shopping Centre from being closed.

The issue was made more complicated due to Victaulic pipe and fittings being used on the original build which required a slightly different approach from a standard installation.

To rectify the issue we drained the system down to allow us to remove the section of pipe and fittings back to the tee piece. We then fitted a 67mm Victaulic coupling, groove a length of 67mm copper, join the copper to the coupler then 67mm press coupler to 42mm press reducer with 42mm to 28mm press reducer and lastly 28mm press valve with a stop cap.
